# Selling Arguments *for* TIN ROOFING

*A review of the advantages of  
roofs of this type*

A textbook containing corrected tables for use in estimating, instructions for laying tin roofs, description of the manufacture of roofing tin, and a large amount of information useful to the practical man.

N. & G. Taylor Company, Philadelphia

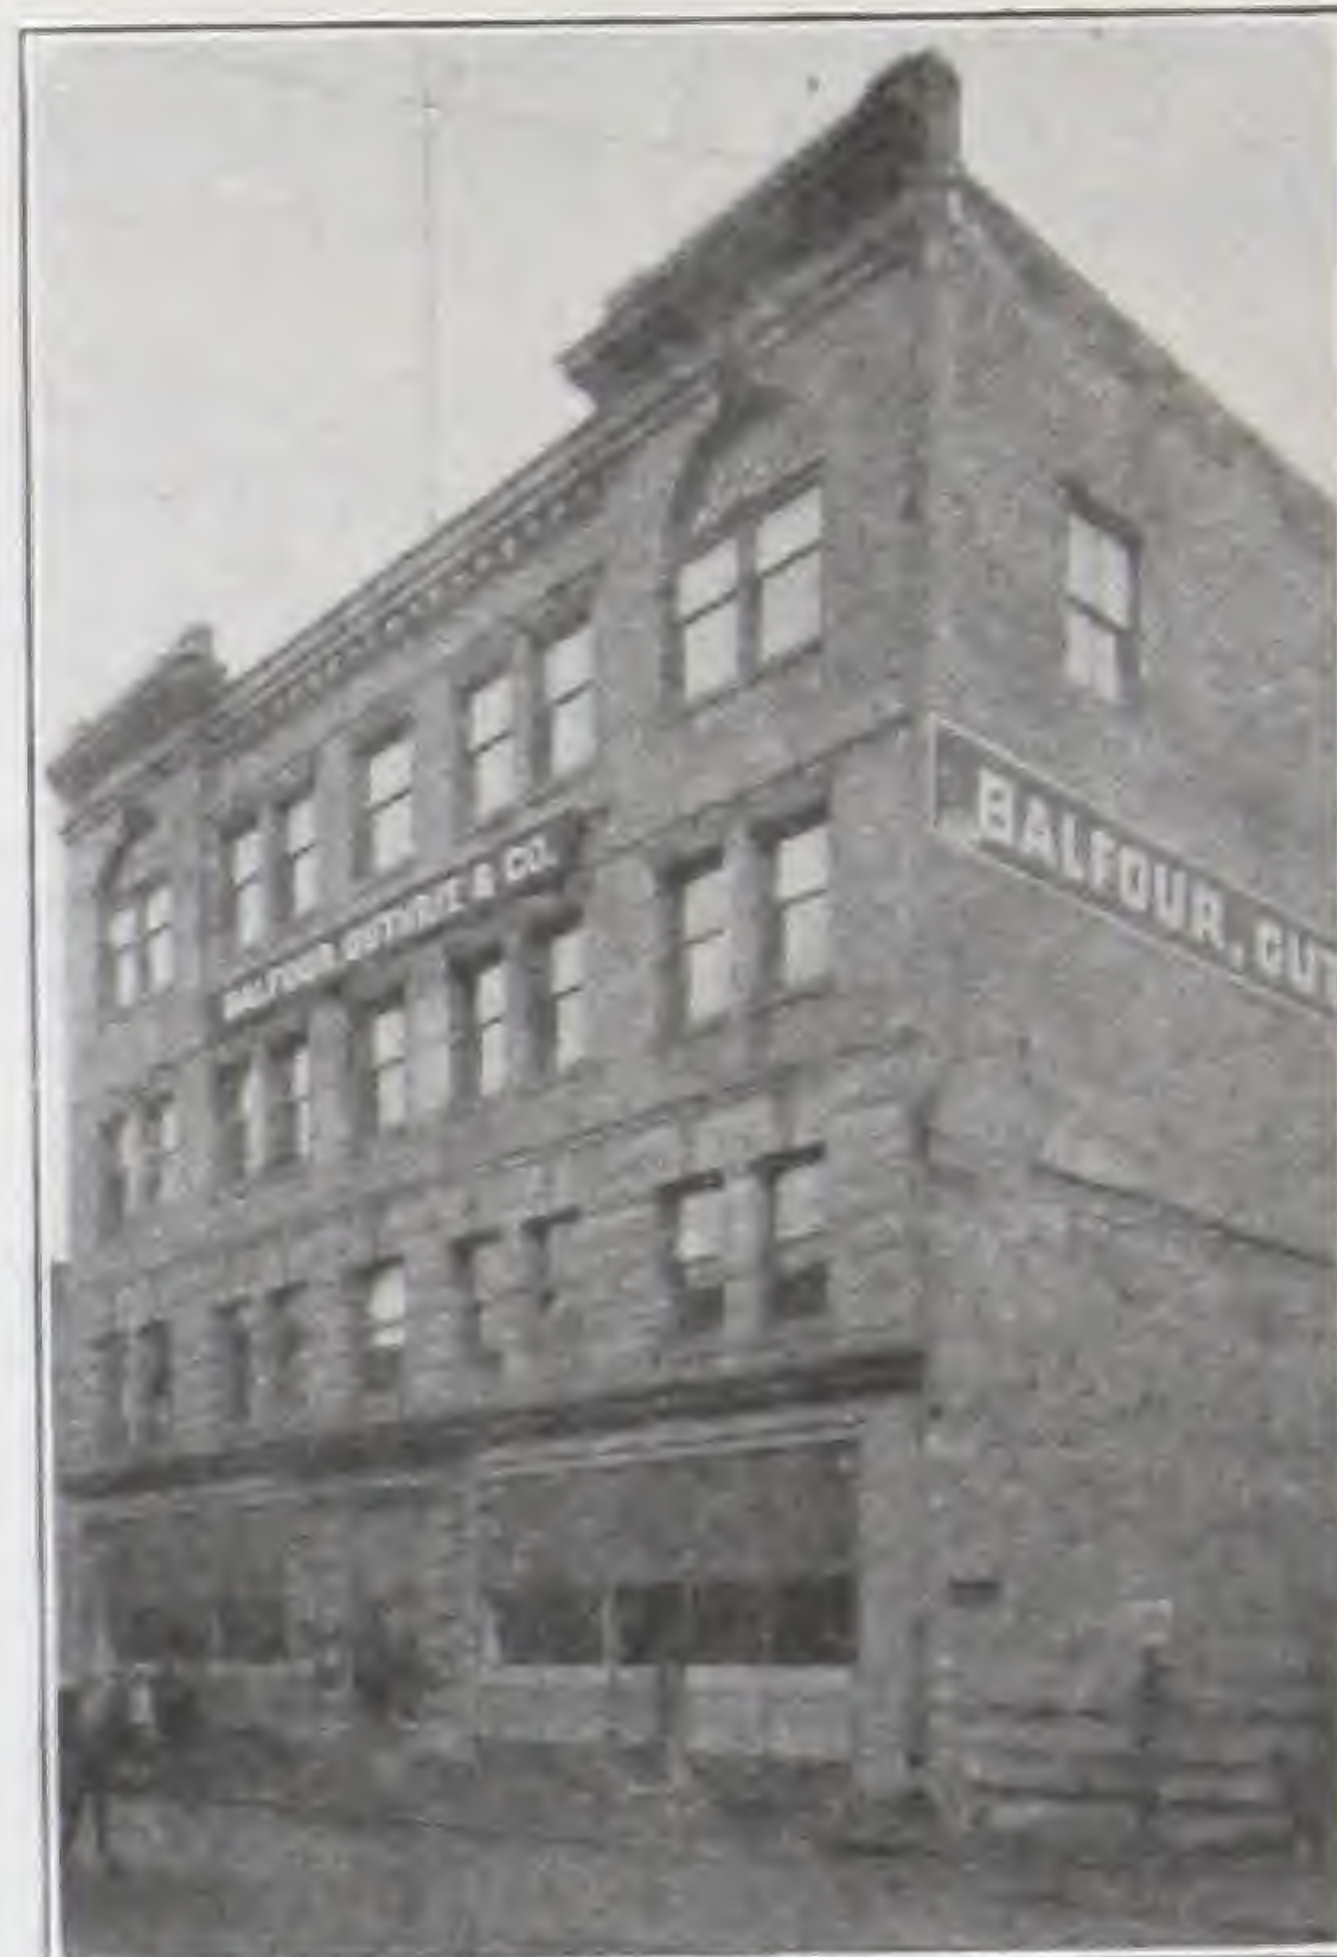
**25. PROTECTION AGAINST FIRE:** This illustration shows the Volkman Building, one of the few buildings that survived the San Francisco conflagration. Both the architect and the owner consider that the roof of our tin covering this building saved it from destruction. The architect writes: "I myself helped to throw great quantities of cinders from the roof, and noted the good condition of the work after the fire. Although the building stood in the midst of a seething fire on three sides, exposed to a shower of sparks and burning embers, the tin work required only a coat of paint to restore it to good condition."

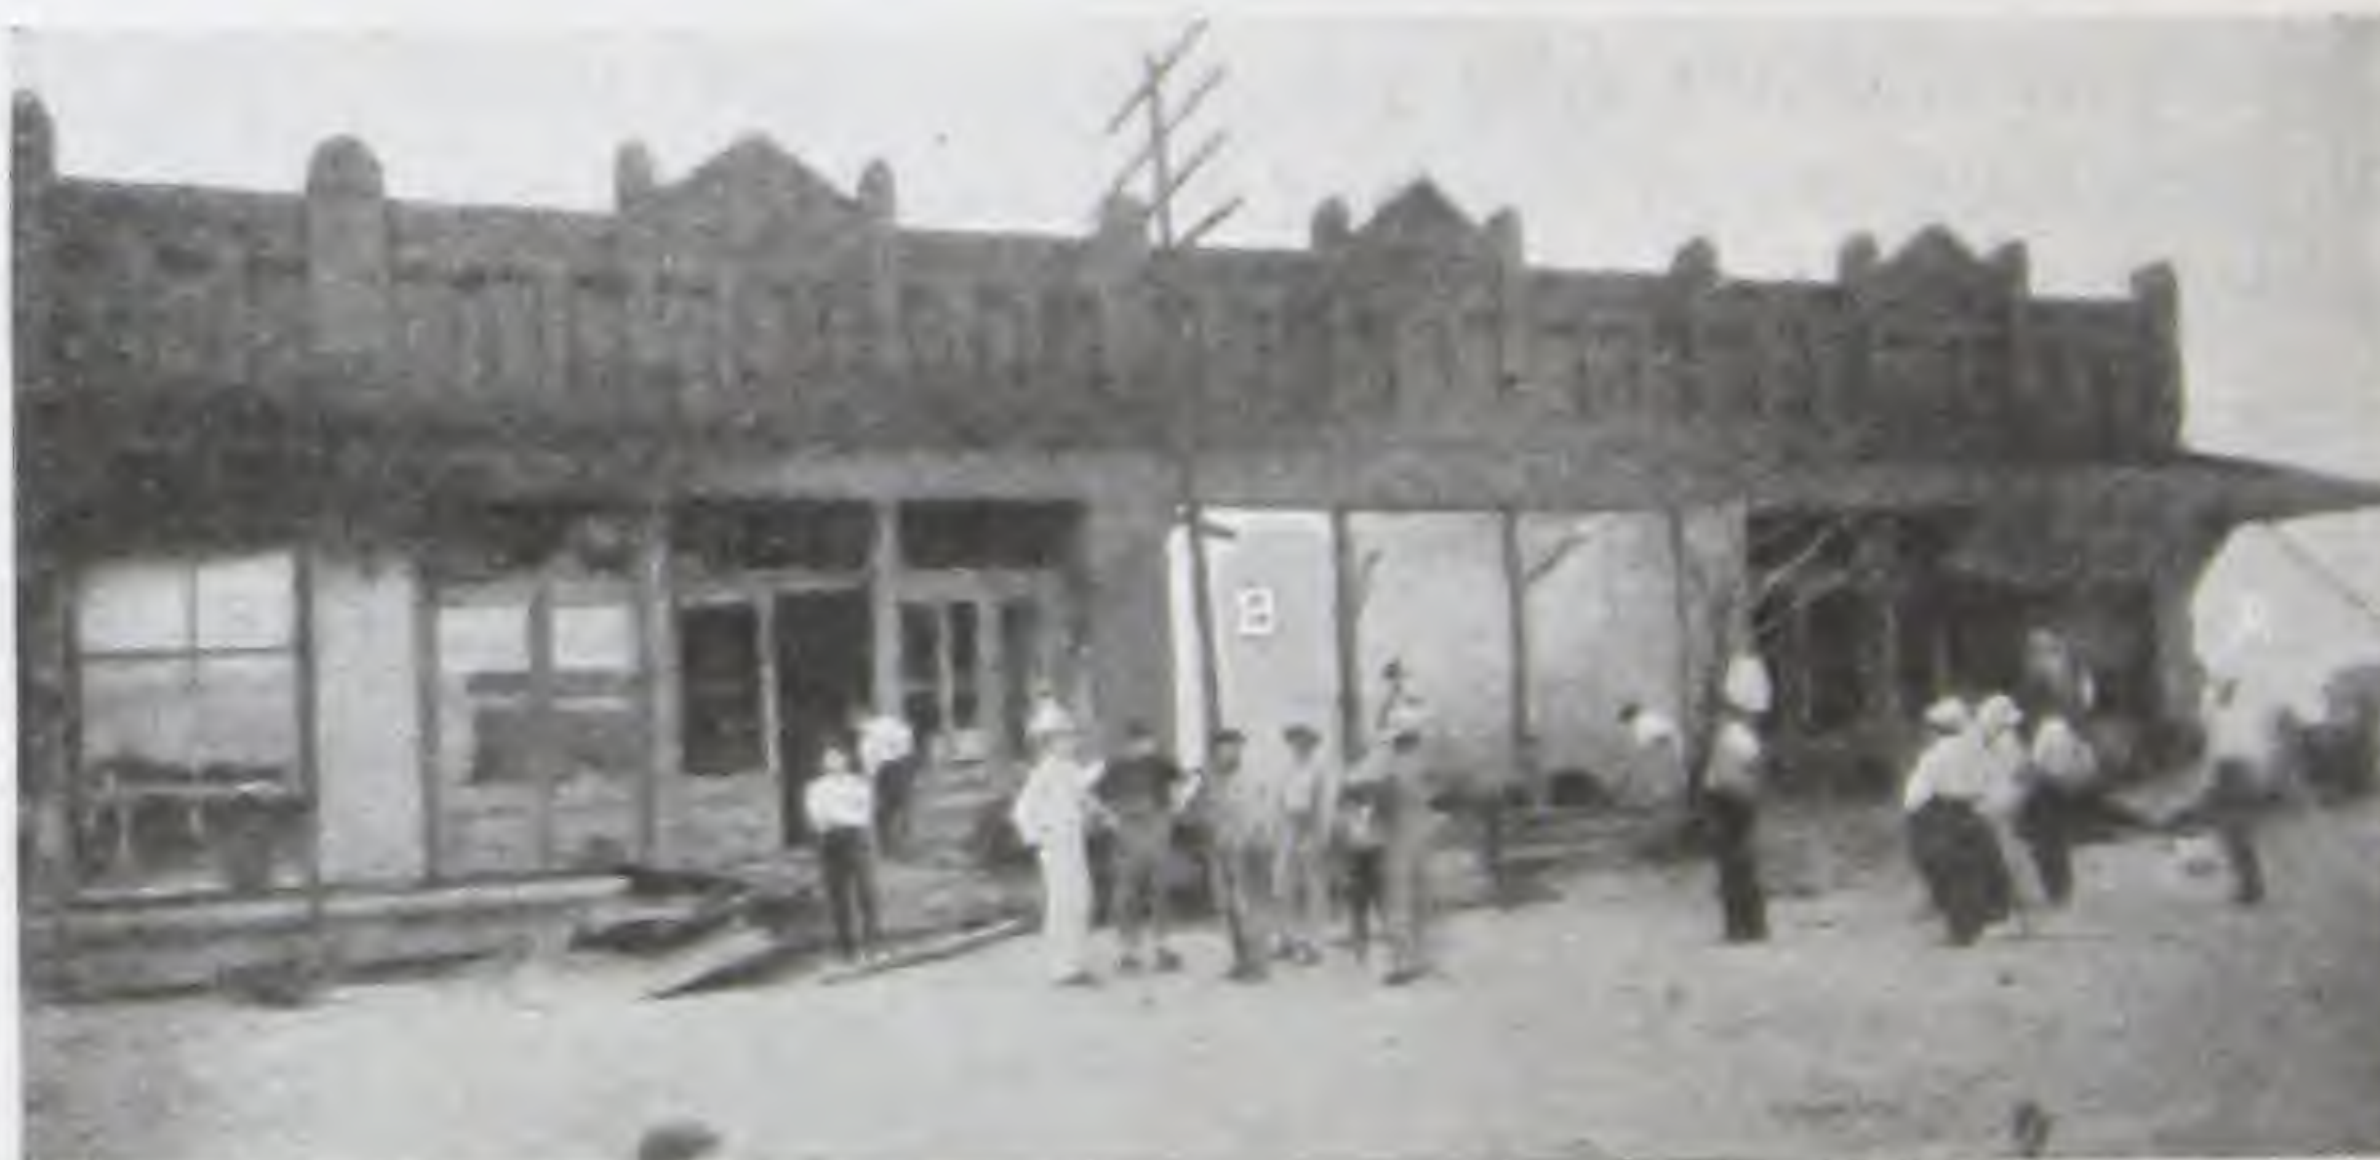
Note that the end building on the right has been *attacked on three sides by fire* without receiving more than slight damage.

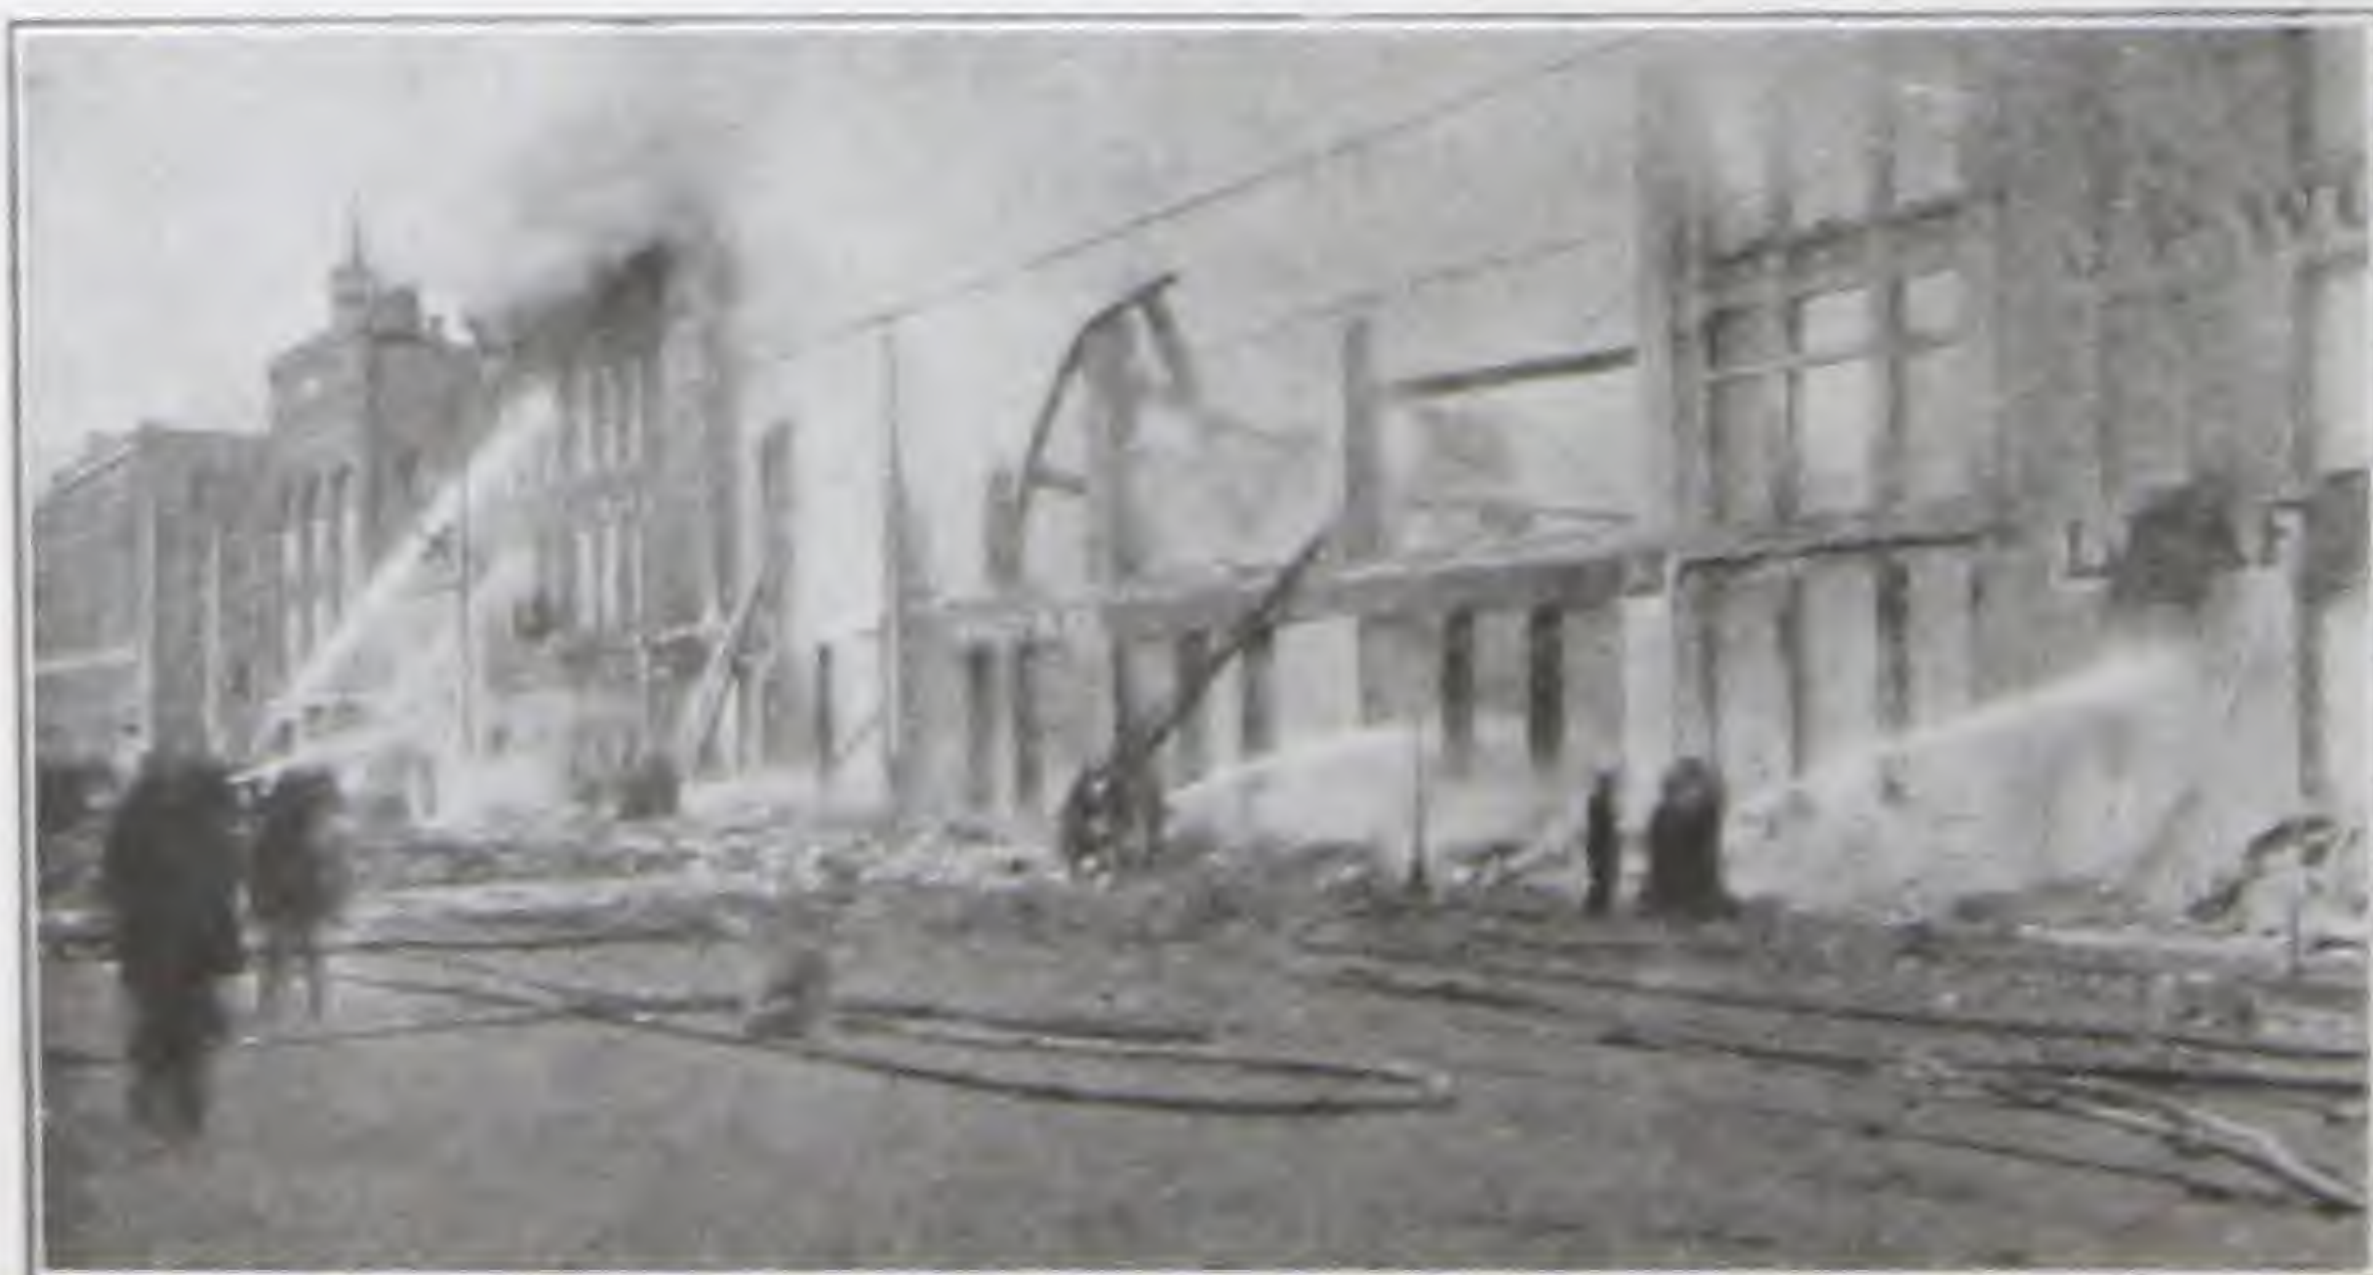
**27. PROTECTION AGAINST FIRE:** In a recent destructive conflagration at Dayton, Ohio, the building in the distance shown in this illustration, marked X, was roofed with tin, and the fire was checked at this point. The tin roof effectively protected the building below from the sparks and debris falling upon it.

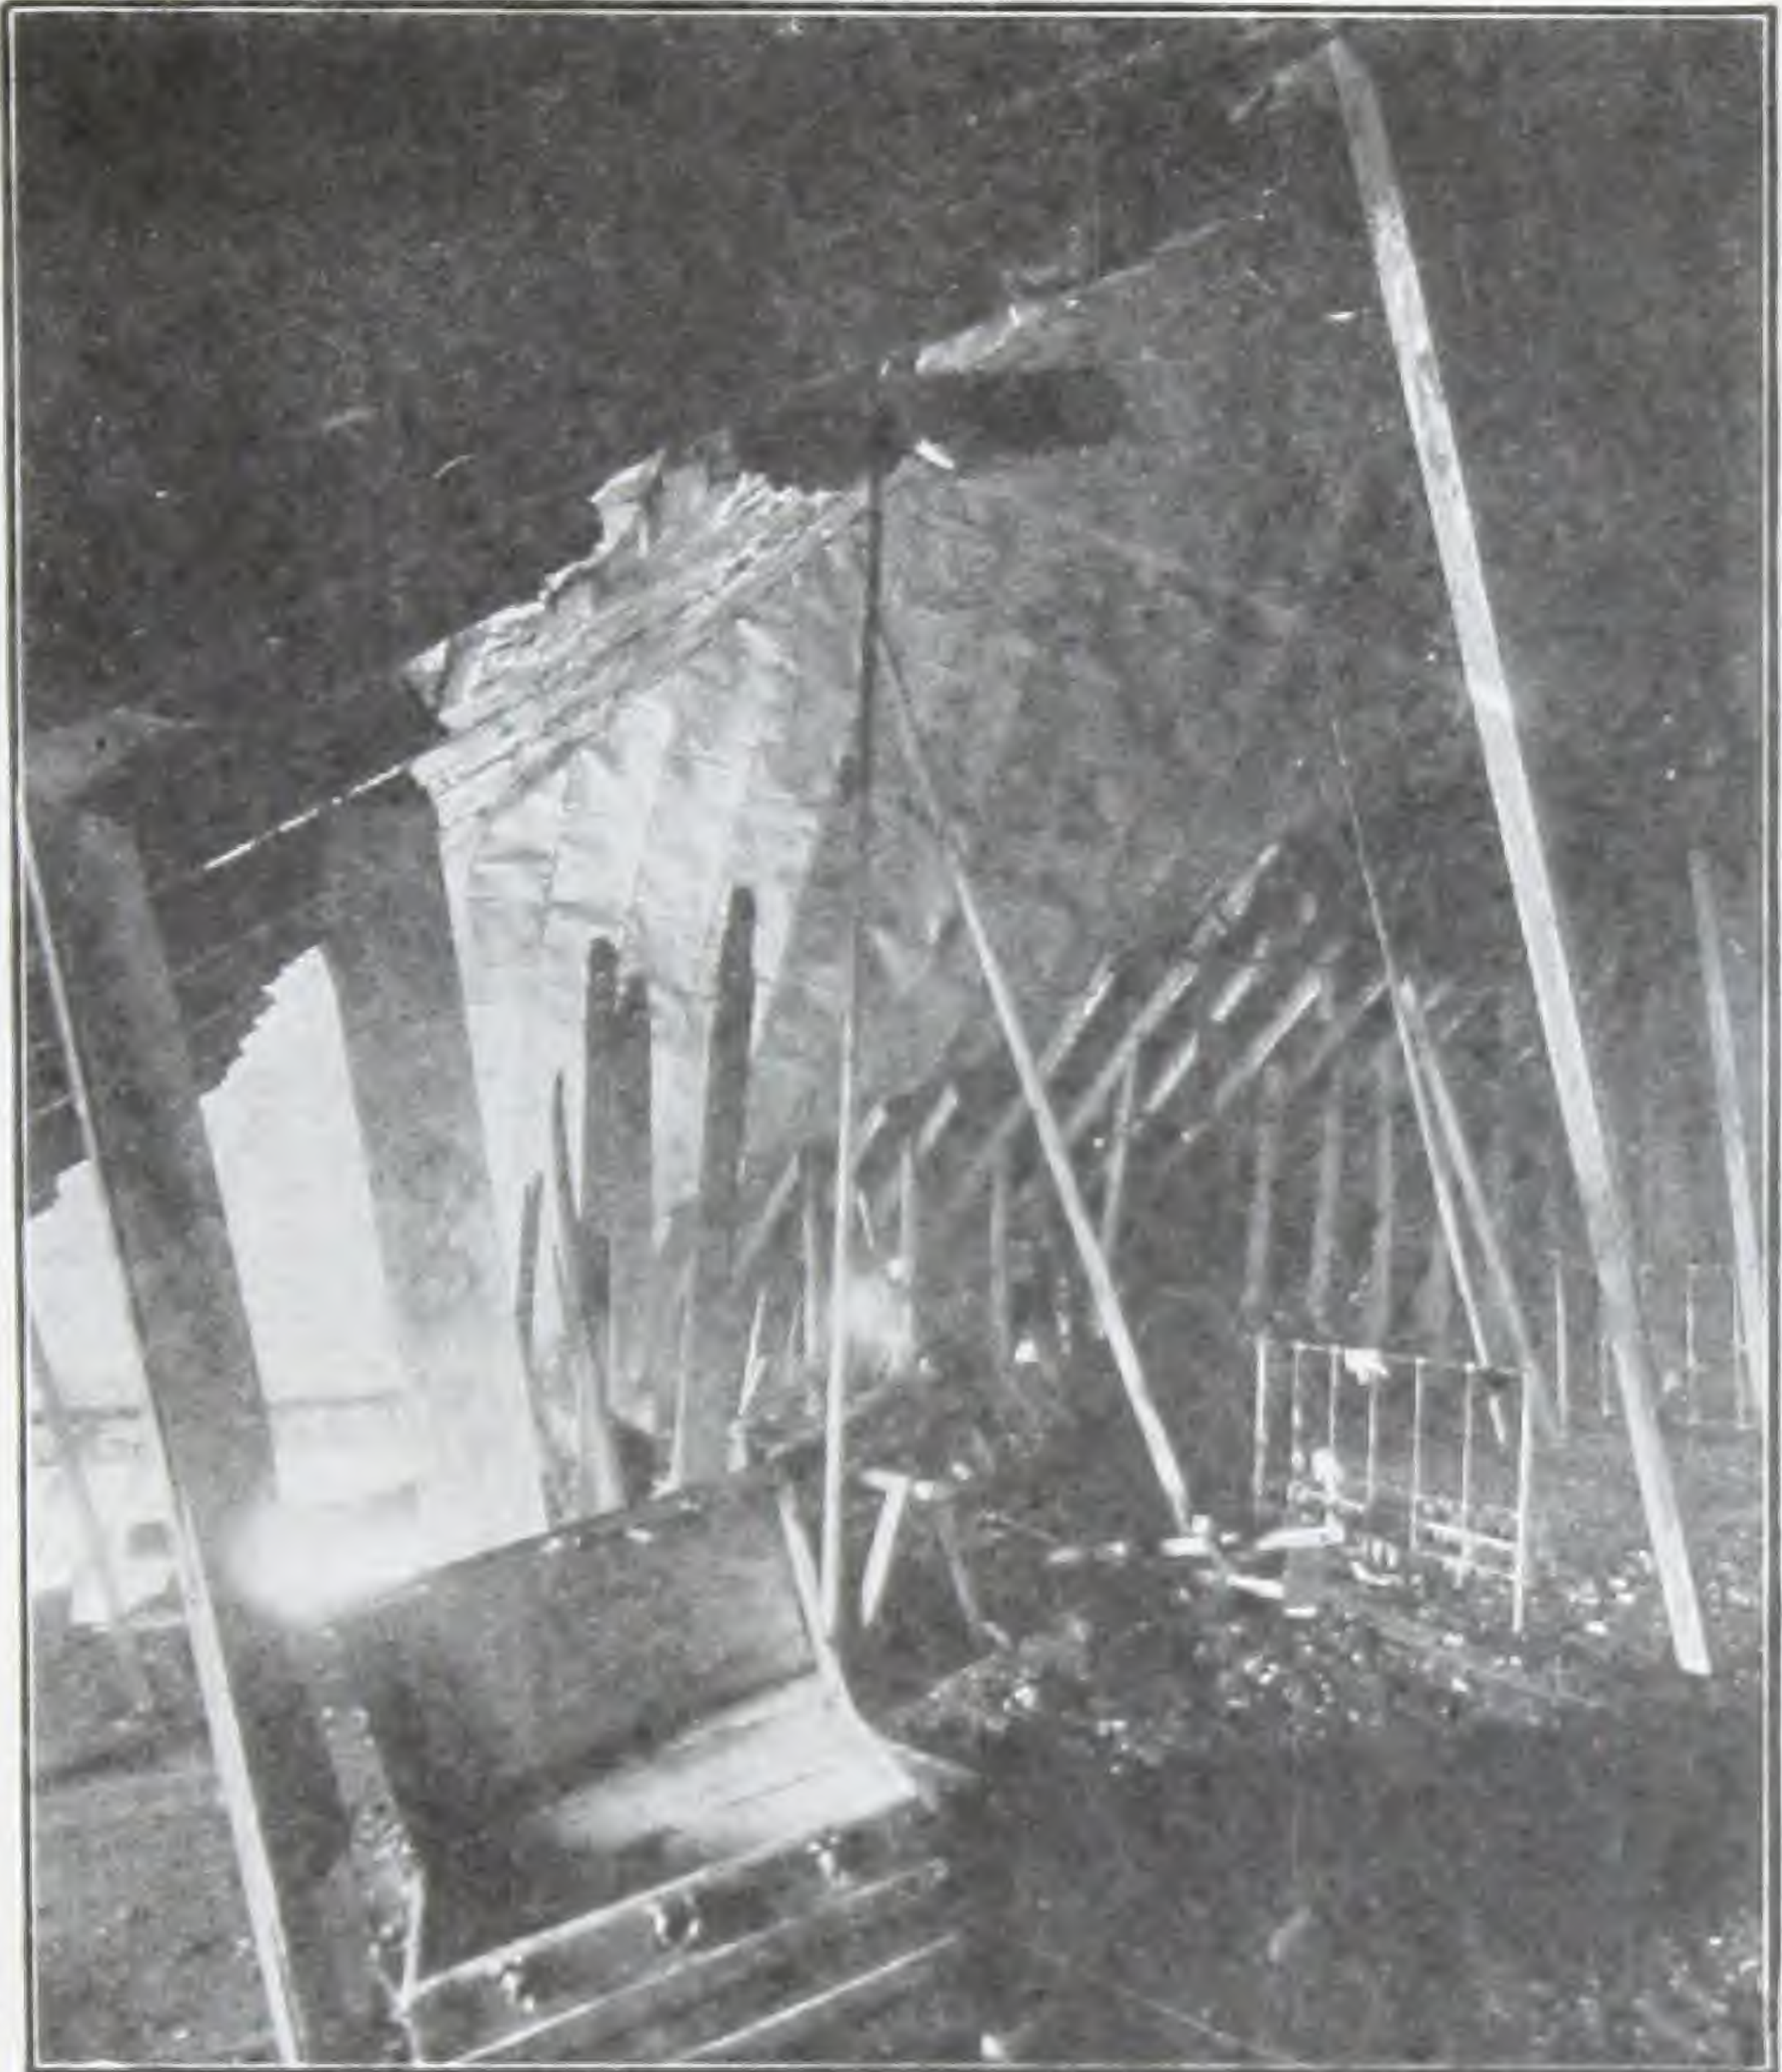
**29. PREVENTS SPREAD OF FIRE:** Another view of the Goldsboro Orphanage fire, showing the under side of the tin. Notice that the supporting woodwork has been destroyed, leaving the tin as a mere shell. The wooden props were put in after the fire to keep the tin from collapsing in the wind.

If this building had been covered with heavy roofing, such as tar and gravel, slate, or tile, weighing from 10 to 20 times as much as tin, the roof would undoubtedly have collapsed at an early stage of the fire, breaking through the lower floors and causing loss of life.

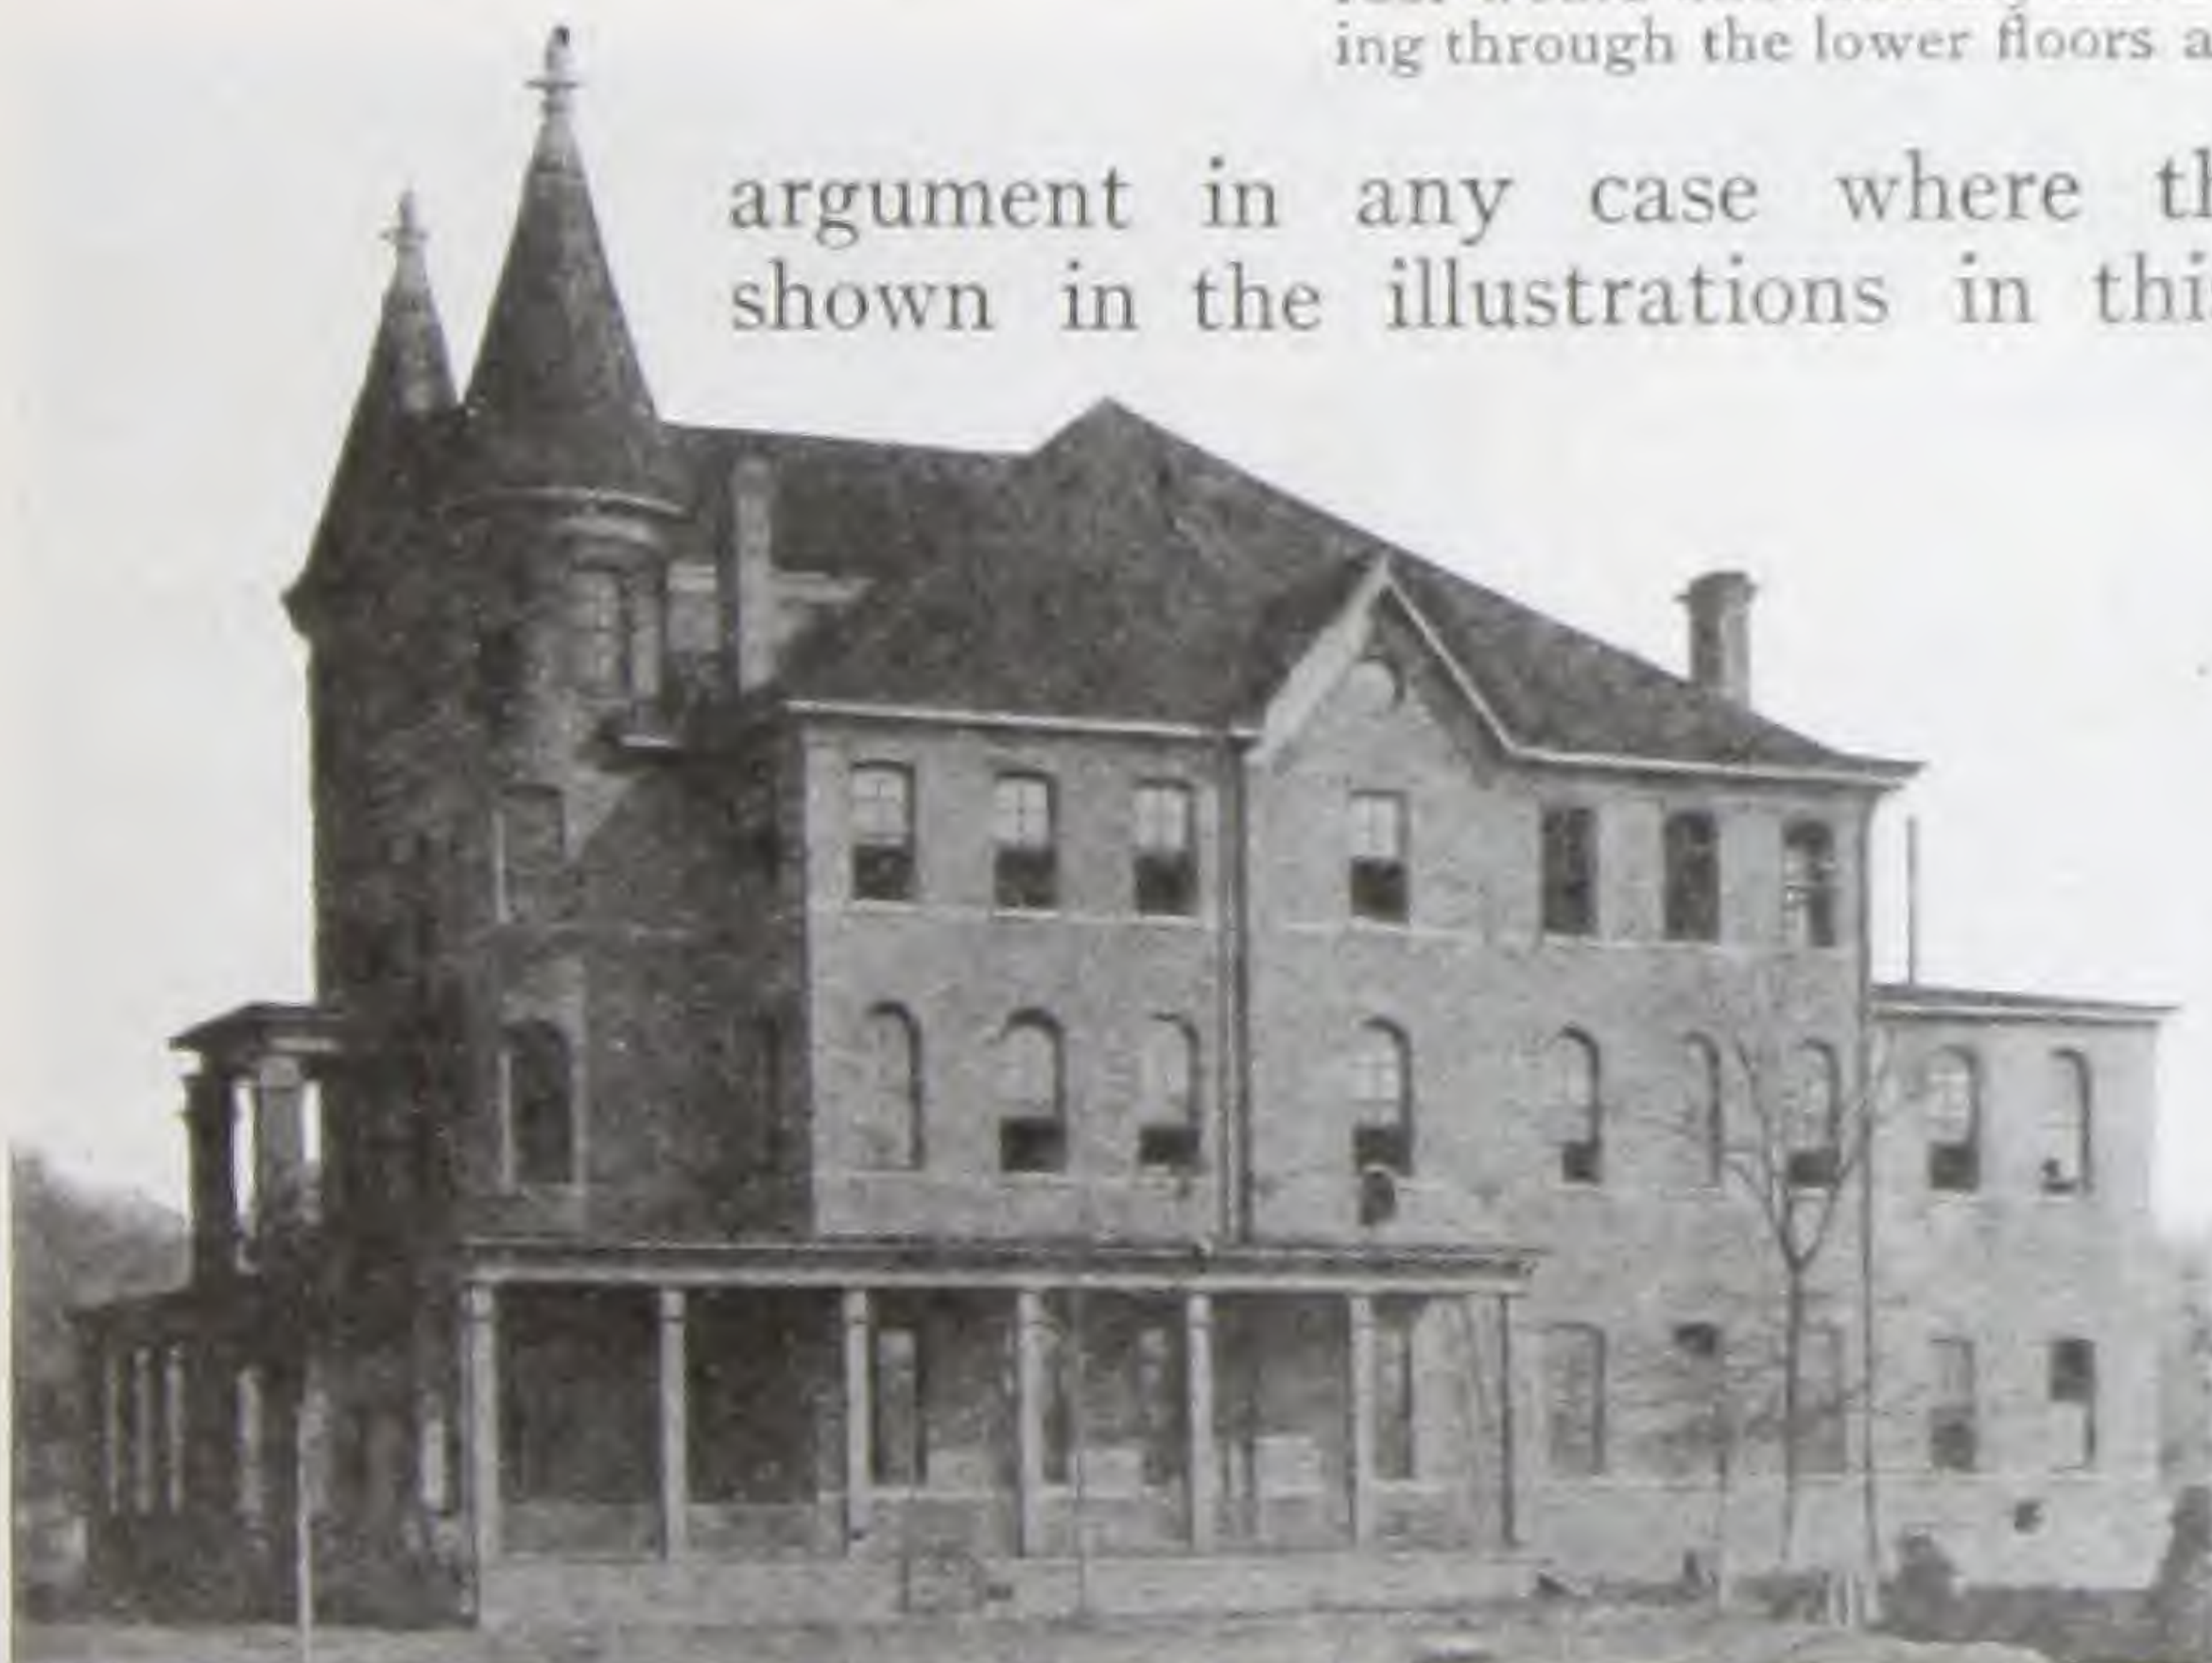
**28. PREVENTS SPREAD OF FIRE:** This view shows the Odd Fellows' Orphanage at Goldsboro, N. C., roofed with our tin, after a recent fire which started in the attic and destroyed the upper stories, at the outset imperiling the lives of 120 children sleeping in the dormitories and on an upper floor. That no lives were lost, and that the fire was controlled without further damage or spread to the surrounding properties, is largely attributed to the tin covering the building. This roof remained intact throughout the progress of the fire, confining the flames. After the fire was over, the tin still held together in its original shape, although only partly supported by charred fragments of the roof framing and sheathing-boards. The tin was left in such good condition that it seemed unfortunate that it had to be removed to build up the woodwork beneath.

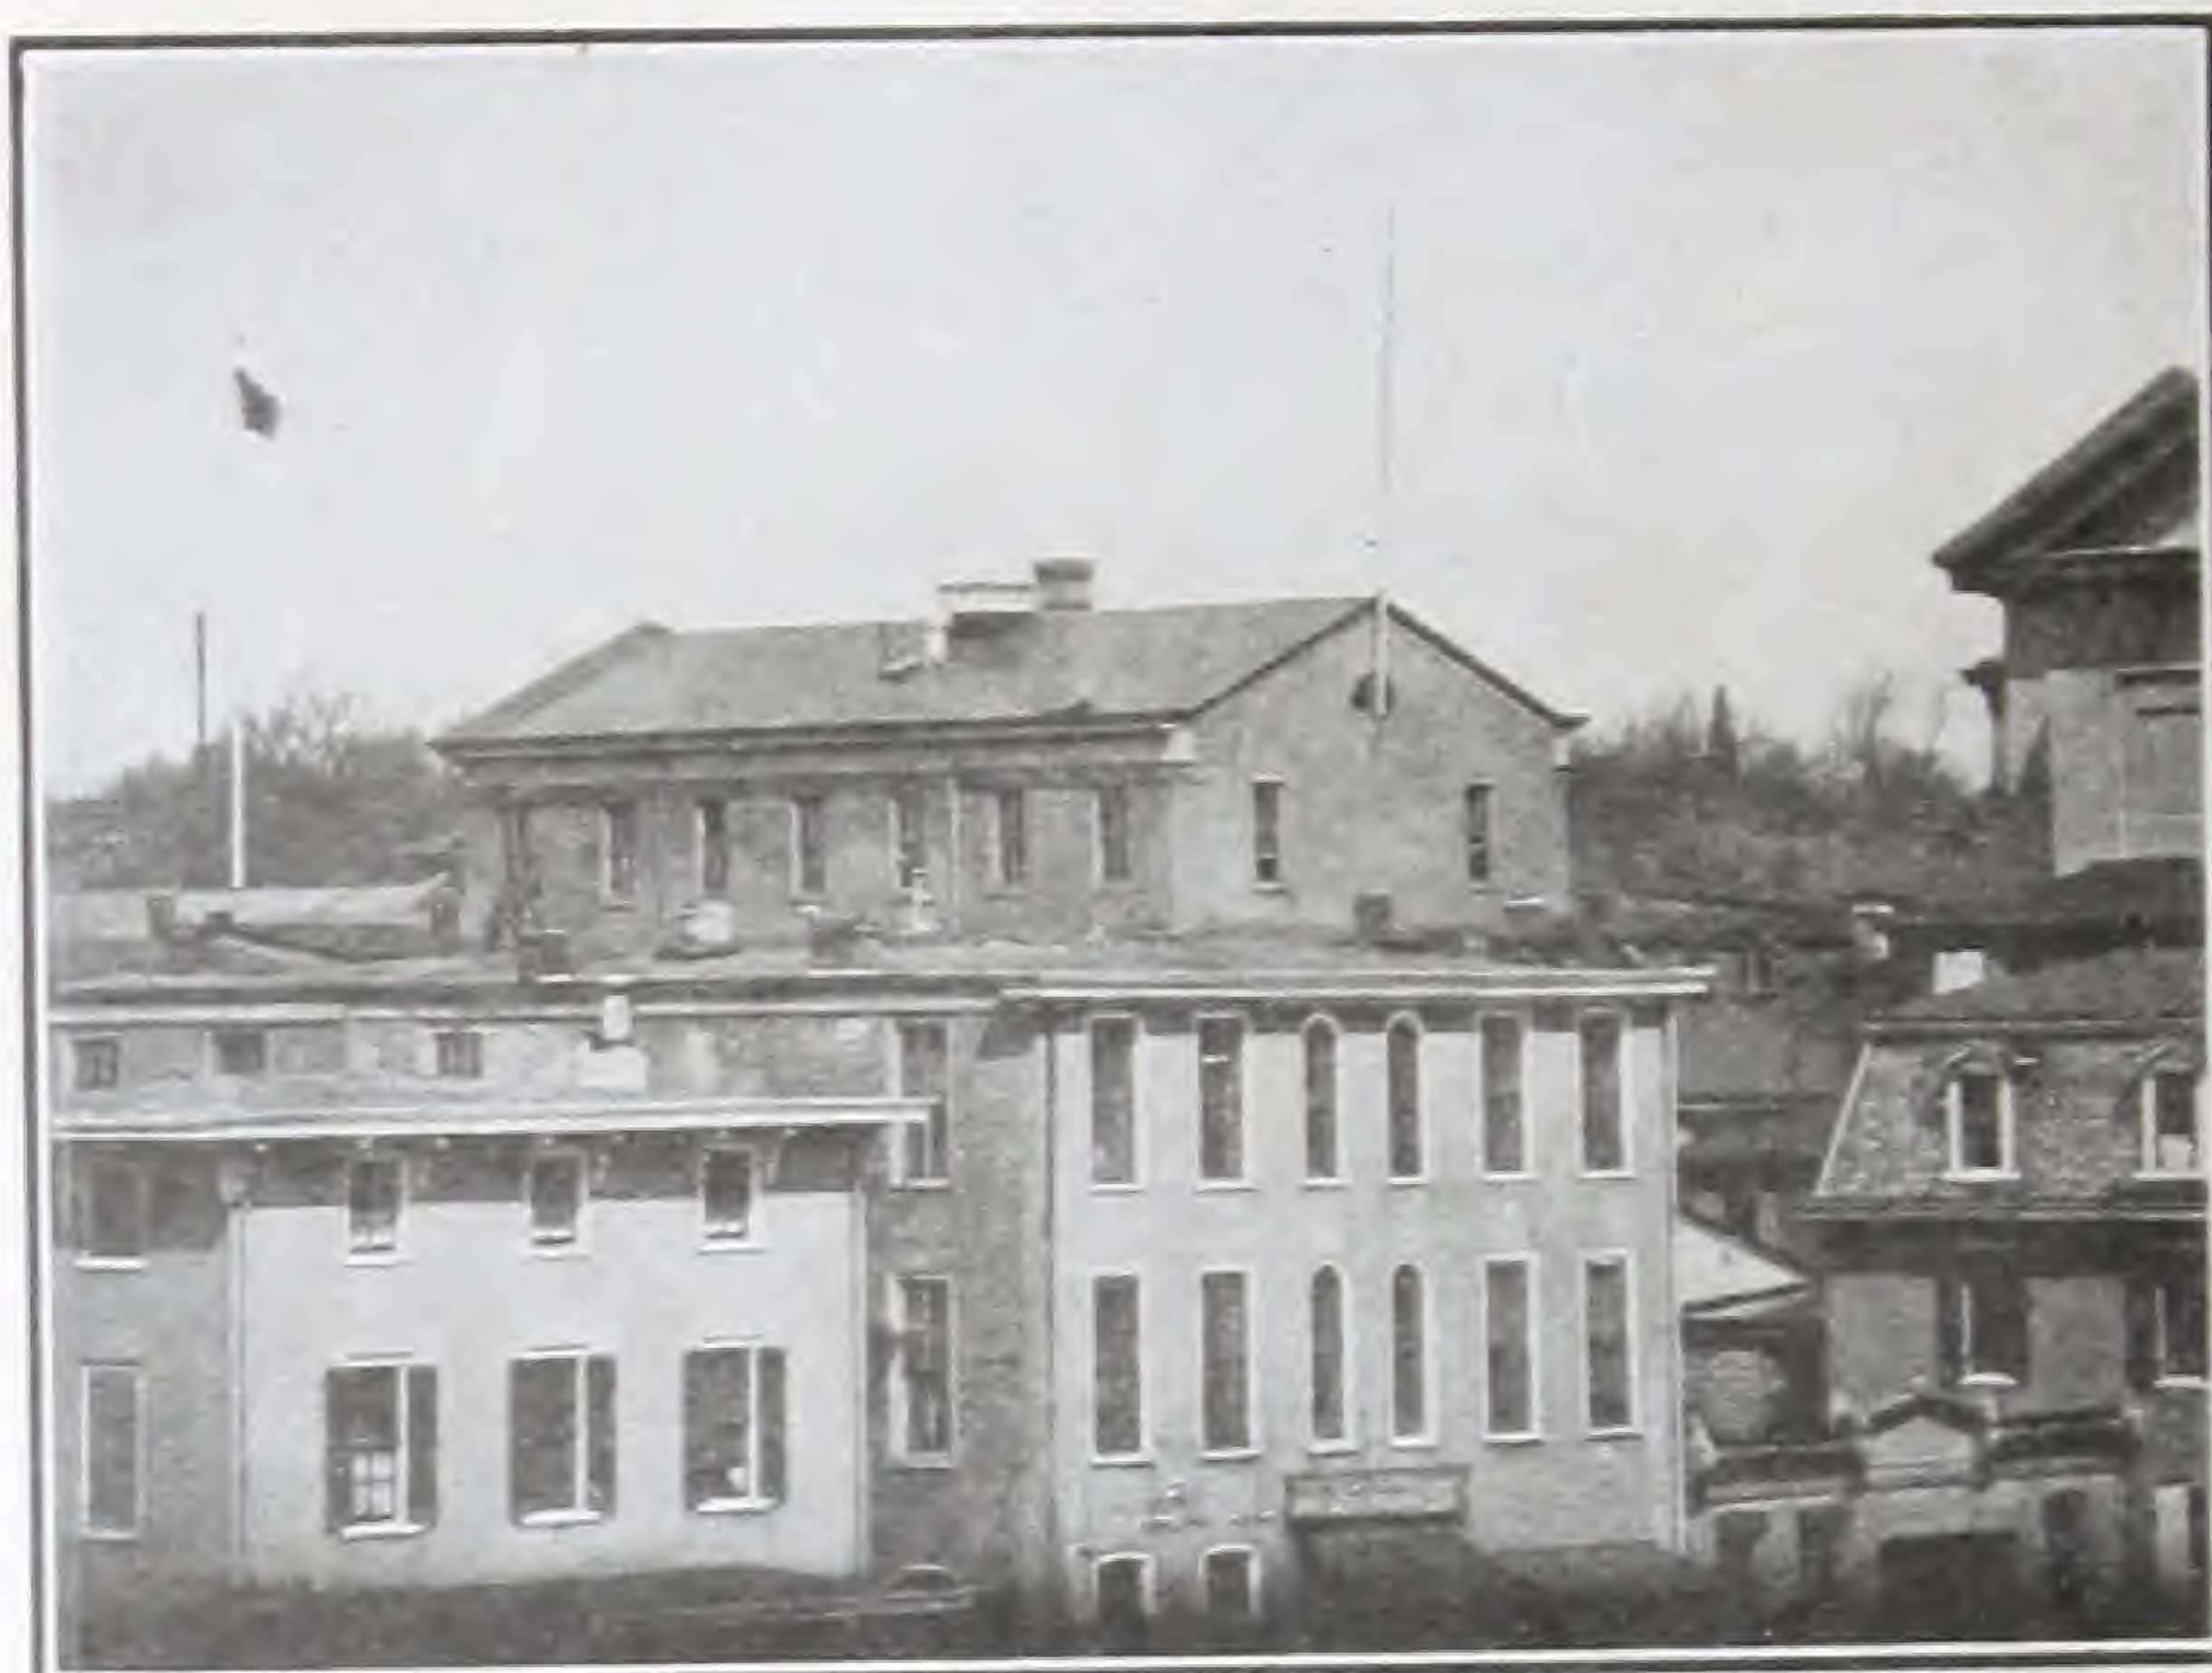
**30. PREVENTS SPREAD OF FIRE:** This illustration shows in the distance the main building of St. Vincent de Paul's Parochial School, located in Germantown, Penna. On February 1, 1909, fire started in the loft of this building directly under the tin roof, and raged fiercely for almost an hour. Although a high wind prevailed, no damage of any kind was done to any of the surrounding properties. Many old buildings surrounded the school, and if the flames had not been held in check by the tin roofing, much valuable property might have been destroyed. This roof was our best tin, put on the building in 1867—42 years before—giving entirely satisfactory service all that time. In repairing the damage done to the roof by the fire the same make of tin was used again.
